Calculating & Comparing Image Quality

The quality of a received Slow Scan TV (SSTV) picture may be determined by comparing, pixel-by-pixel, for identical matches in RGB color space for the customary image displayed on an SSTV cam in JPG format.

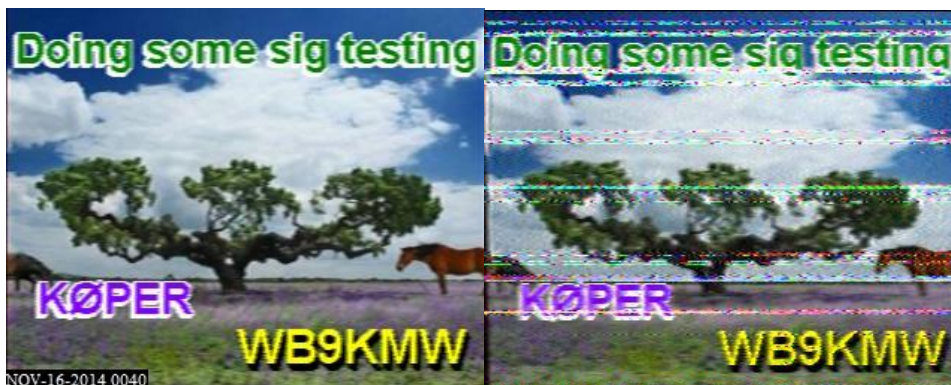
For example, numerous tests were made at various **fuzz levels**. Here is a typical example. The original SSTV transmission is on the left. The other picture was received 897 miles away by AE5TC in Texas.

Picture Fuzz Quality	
0%	0.11%
10%	63.84%
20%	80.38%
30%	87.94%
40%	93.02%

Looking back at that image received by AE5TC, a 0.11% picture quality does not make sense. And further, this will not make sense when we later discuss the P-scale, a broad picture quality scale that is sometimes used by broadcast engineers to describe video quality.

Likewise, it starts to become a stretch to claim that this received image possesses 80.38% picture quality. So one may compromise with the arguable but reasonable 10% fuzz level as a normal default when expressing picture quality. All further discussion in this article will always assume use of a 10% fuzz factor.

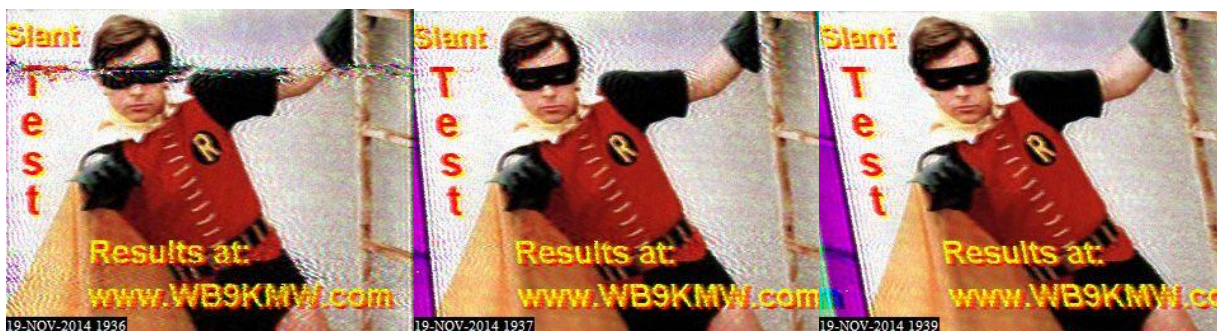
The received images from Steve NS3L's SSTV cam were analyzed. Here are received images for straight, 1 Hz and 2 Hz slants, yielding picture quality percentages of 72.71%, 60.95% and 45.86%, respectively.

Some hams do not **properly align their soundcard**. This introduces another element of image distortion before the RF signal ever leaves the antenna. A series of transmission studies were conducted over a brief 11-minute period, starting with perfect Tx image alignment and progressively altering the slant.

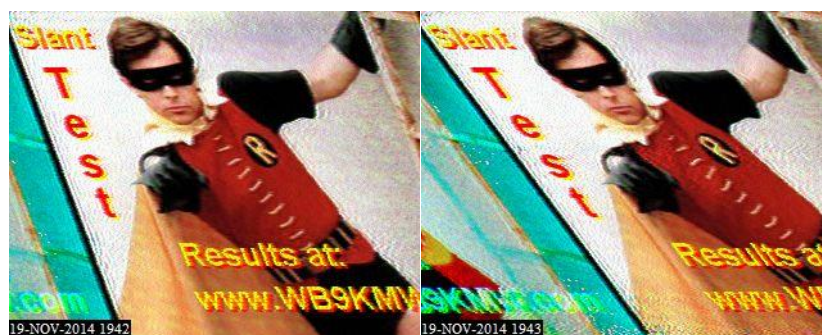
Next the transmissions were further skewed 4 and 8 Hz. These pictures scored 27.52% and 16.74%. So even with rather uniform band conditions, just misaligning the transmission software creates significant distortion error. About the only thing going for Robin is that his ladder remains modestly straight!

Notice the call letters in the URL. When hams call CQ with such poor transmission alignment, others sometimes cannot make out the call sign of that station. Hence, their CQ goes unanswered.

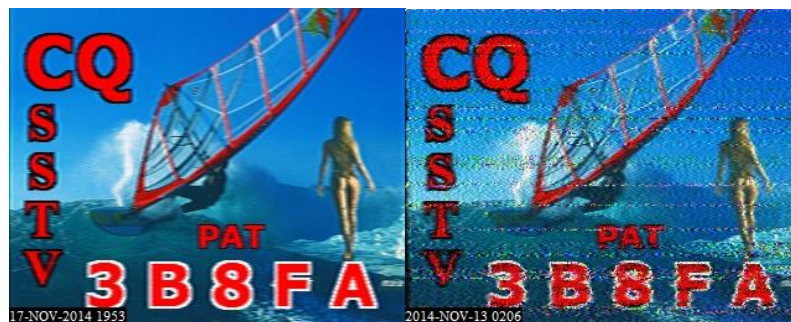
Path loss from the ionosphere plays a crucial role in picture quality. Four signals from Pat 3B8FA were captured one evening from a distance of 9,872 miles over a 35 minute span. Pat later shared his original image which was used for these calculations. On the left is the original picture, one he uses frequently, and the first one received at WB9KMW with 62.31% picture quality.

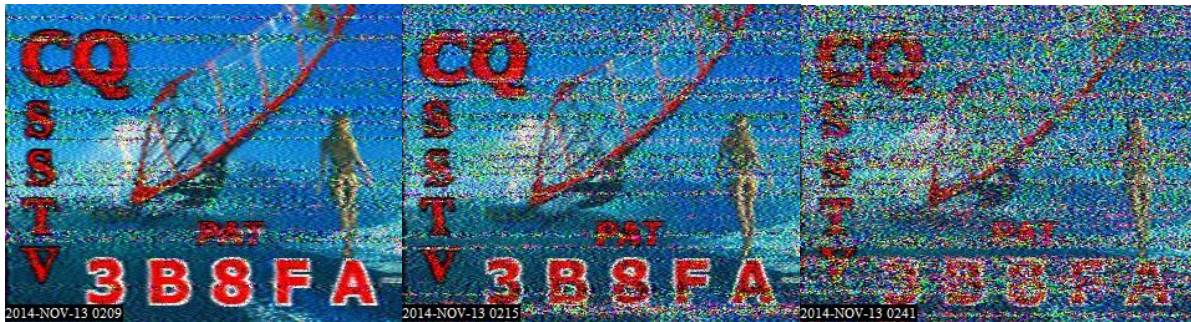
Then in subsequent minutes he retransmitted, and three more pictures were received, which scored 52.60%, 27.93% and 11.62% as band conditions worsened. After that, transmissions failed to arrive.

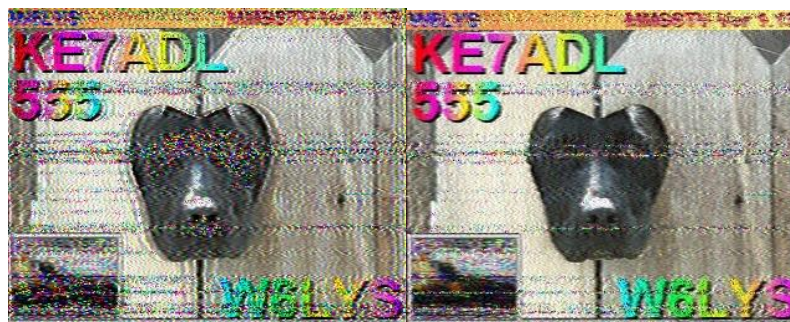
The difference: The image on the left received its audio from the headphone jack, fed it into the microphone jack of a Dell computer and used a stock RealTek soundcard to decode the signal.

With the better image on the right, audio came from the line output of the ACC2 jack in the Kenwood radio. This was fed as line input into an ultralow noise (-124 dB SNR) Sound Blaster ZxR soundcard mounted in an HP computer.

The image quality on the left is only 44.01% of the better one that was decoded on the right. So with superior configuration in this example, there is a 2.27 times improvement in quality (100/44.01). This is a 3.56 dB improvement, or in ham terms, approximately one-half S-unit better reception!

On the receiving end, the manner in which ones **receiver and soundcard are configured** makes a big difference in decoding the SSTV signal. In this next experiment, the same transmission at the same time with the same Kenwood TS-590S transceiver was copied.

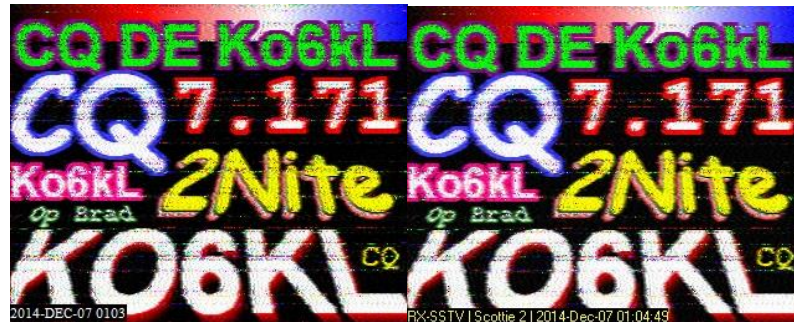
Subsequently, the Dell computer was moved from the Kenwood headphone jack to a **shared connection for line audio output from the ACC2 jack, and fed as line-in audio to the computer**. The most significant remaining difference was the RealTek soundcard, versus the Sound Blaster.

The difference in picture quality of a sample image was measured. Now the one on the left with a RealTek soundcard scores 90.87%, compared to the right image.

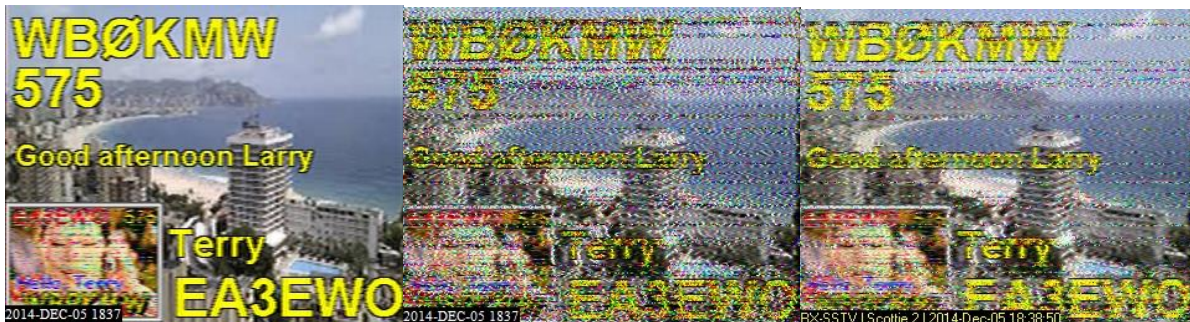
Yet having superior configuration can make an important difference in the quality of a QSO, as the following transmission from Terry EA3EWO displays. His original transmission is on the left, the RealTek fed via microphone in the middle and Sound Blaster ZxR on the right.

Now compared to the original transmission, the picture quality percentages are, respectively, 31.33% and 47.81%.

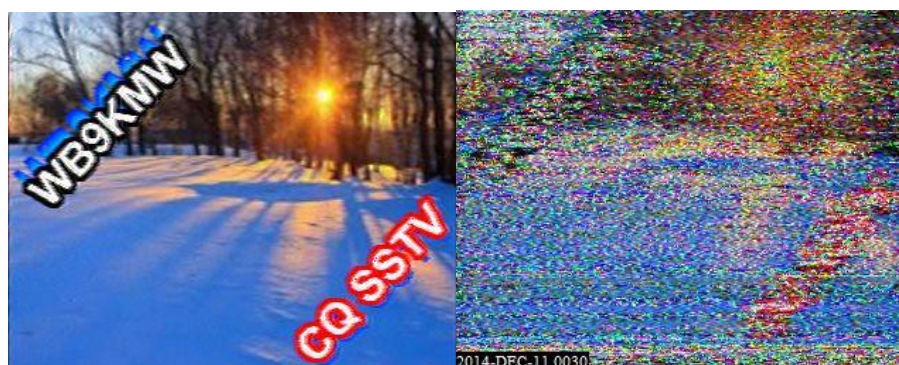
Sometimes one gets to see the **near extremes of reception** when observing signals as received from afar and published by SSTV cams. In this case, very good reception (91.58%) was obtained by VE6PW in Calgary, Canada (1,252 miles away) and very poor quality (13.49%) was an image detected by NX0S in Missouri (393 miles).

P5: broadcast quality Some transmissions, such as the VE6PW reception (91.58%) shown on a previous page come very close to broadcast quality. However, even if noise bars are not apparent, there is enough pixel degradation to mark most images down to the P4 level. True P5 picture quality, which lies more than 2 standard deviations above the statistical mean, is indeed rare with analog SSTV.

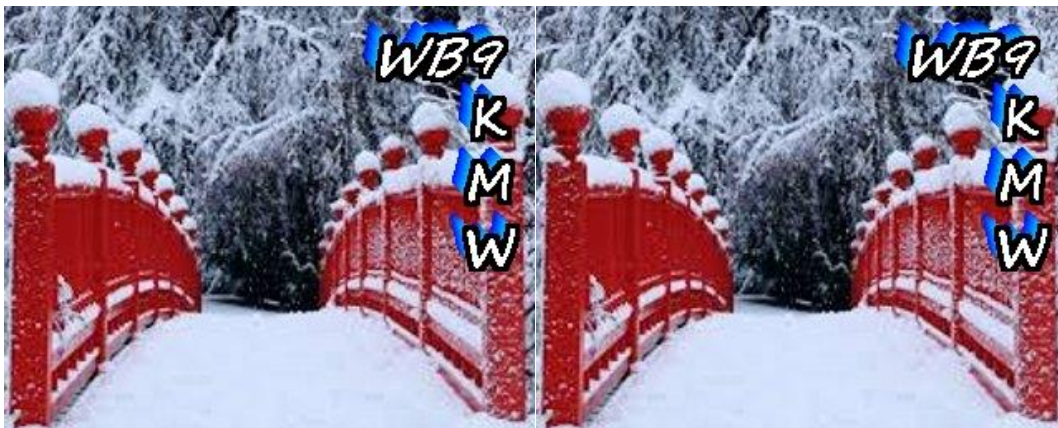
I was able to active a perfect 100% match under very controlled conditions. This involved transmitting at 5 watts into a 40 meter ICOM 706 MKIIG transceiver in Martin 1 mode, with one very important adjustment: The frequency from the Kenwood TS-590S transceiver was lowered by 60 Hz until it matched the actual frequency of the ICOM rig. This can be determined by examining the 1200 sync tone in the MMSSTV software.

For a 320x256 px image, the signal-to-noise ratio = $10 \log (320 \times 256) = 49.13 \text{ dB}$. This is the point where every pixel in the received image exactly matches every pixel in the original transmitted image. In the days of B&W 405 line television, studio quality images from iconoscope television cameras had a signal-to-noise quality of 55 dB in a fully lit studio.

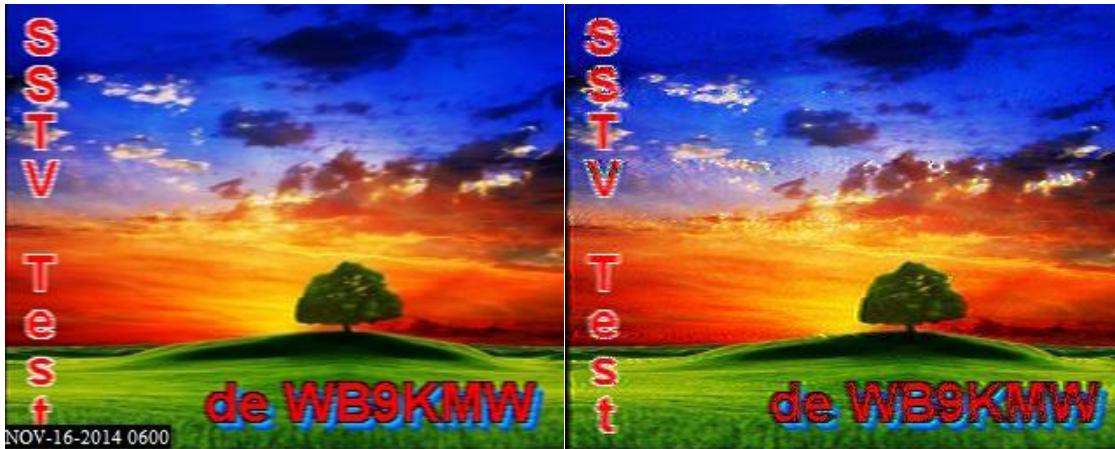
P4: good, some noise This reception from N9UWE has just a hint of noise, and serves as a nice example of a P4 image with 87.70% picture quality.

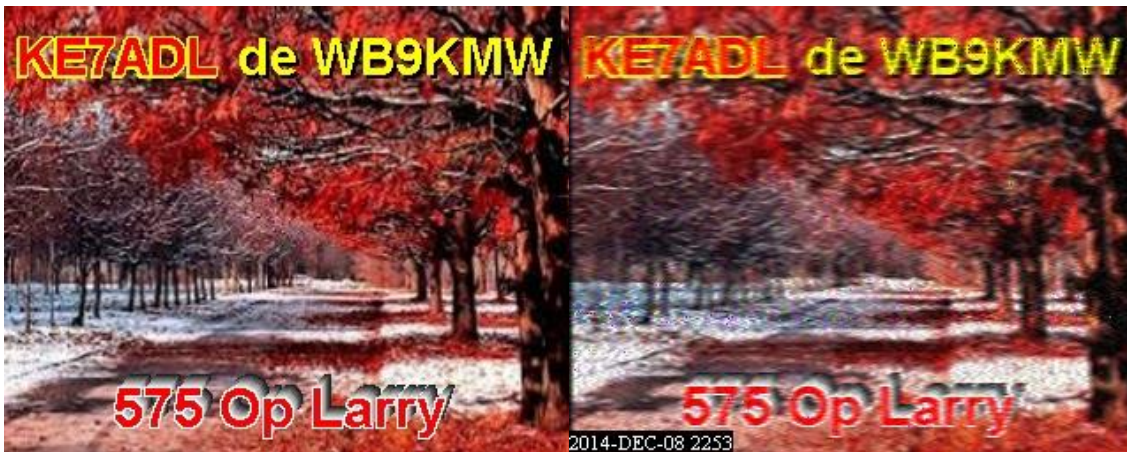
P3: usable, noisy A P3 picture quality is more commonly received. Some with a bit more and some with a bit less noise than displayed on this representative picture as received by VE1DBM, measured at 63.40% picture quality.

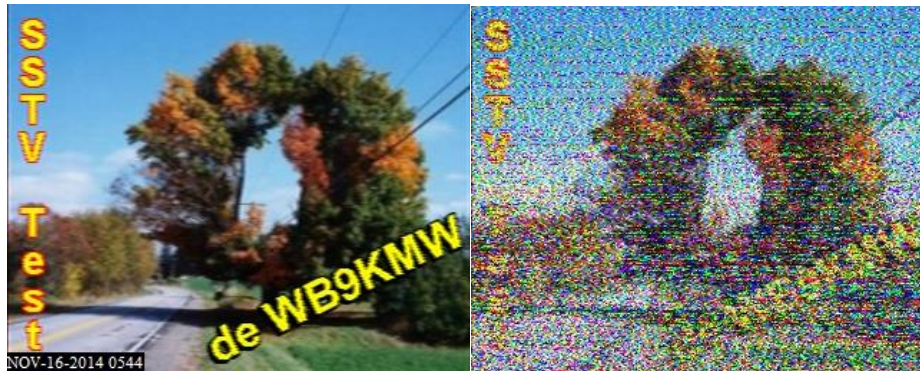
P2: barely use, noisy This image was received by VE6PW while the ionosphere was in the process of fading out for the evening. The measured quality is 25.78%.

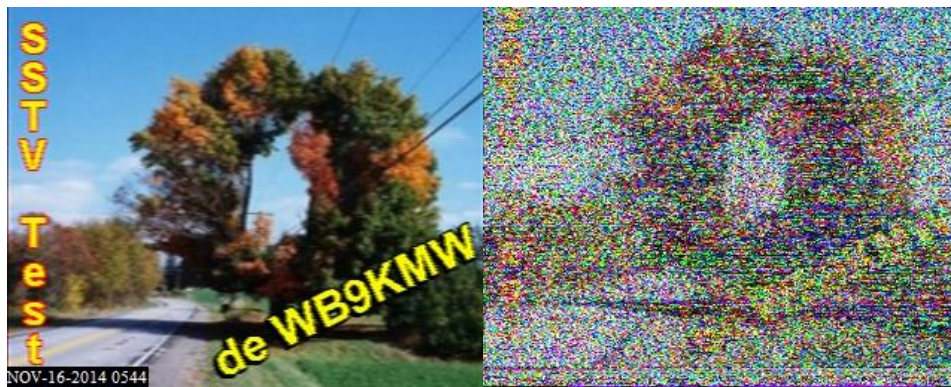
P1: barely see text A few minutes later, VE6PW could hardly copy the next transmission. Now the picture quality is only 7.64%.

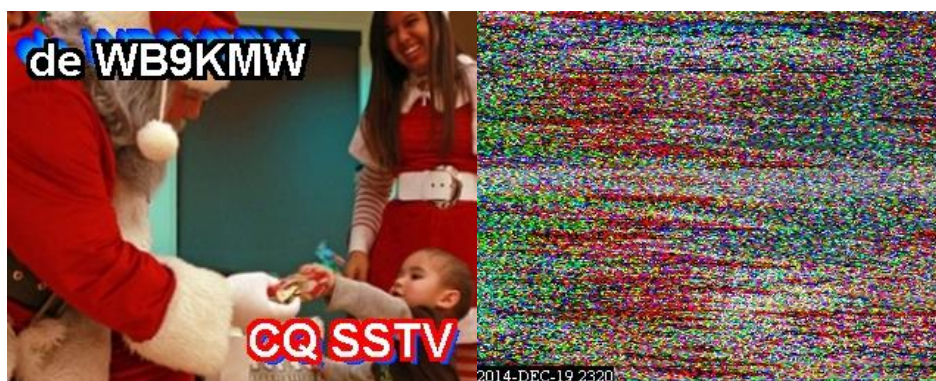
P0: unusable Most of the time, signals with a quality score more than two standard deviations below the mean, ie, lower than 2.3%, are impossible to fully copy. The MMSSTV software may lock onto the transmission for several seconds, but cannot maintain image copy for the full minute plus from most SSTV transmissions. While not quite P0, this example has a picture quality of 5.96% compared to the original.

Todd KD0TUU is only 250 miles from WB9KMW, so the station is normally in the skip zone and receives nothing at all.

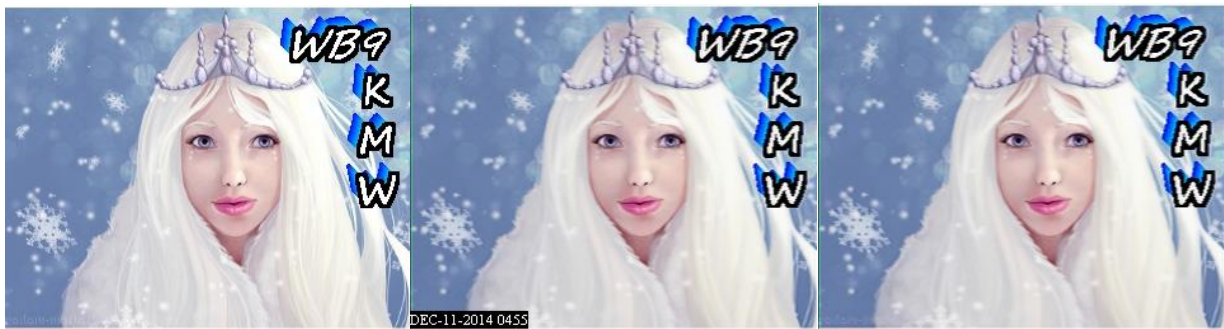
Let's consider the same received image with and without the time stamp inserted. Here they are, again with the originally transmitted image on the left.

The picture qualities are 93.22% with time stamp and 94.79% without. So in this example, the time stamp degraded the image by 1.57%. Almost all the time, SSTV cams include a time stamp, so it is difficult to avoid this added distortion of the originally transmitted image. The improvement is indeed small, ie, only 0.07 dB.

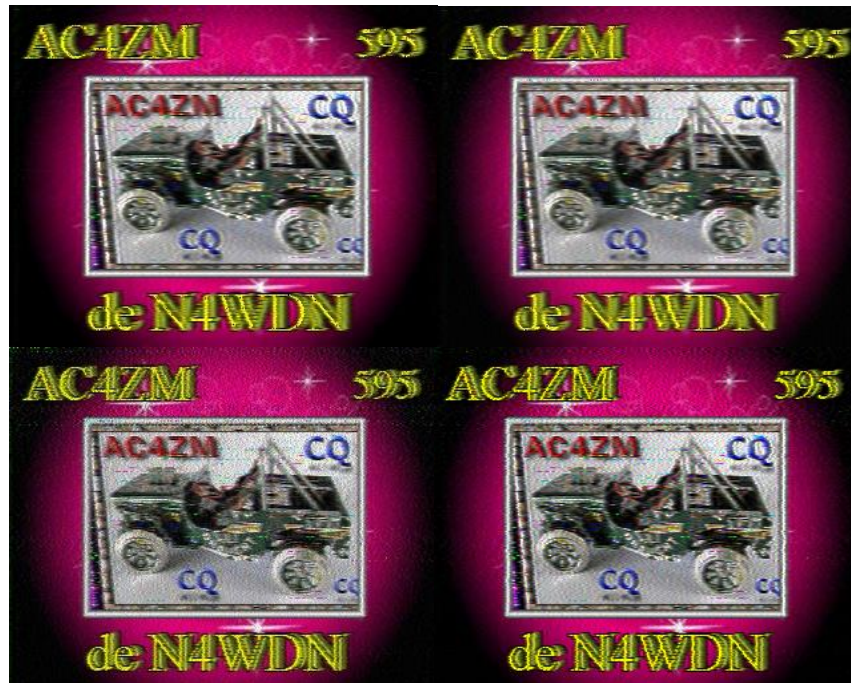
Here is an example with a reasonably strong signal. MMSSTV was found to consistently decode the best. So all picture quality statistics are relative to this strongest standard.

All four images look rather similar, but compared to MMSSTV on the top left, quality scores are as follows: RX-SSTV (which uses the MMSSTV engine): 98.52%, DM-780 (found inside Ham Radio Deluxe): 86.00% and ChromaPix (bottom right image): only 62.83%.

So for this particular study, MMSSTV is a mere 1.015 times better (100/98.52) than RX-SSTV, however, the differences are pronounced when comparing MMSSTV to DM-780 (1.163 times better) and ChromaPix (1.592 times better). These are 0.66 dB and 2.02 dB improvements using MMSSTV. Recall that 3 dB is one-half S-unit better reception. The value of MMSSTV will be even more evident when one looks at the weak image that is subsequently analyzed.

To help answer this, MMSSTV, RX-SSTV, DM-780 and ChromaPix were operated simultaneously to decode SSTV transmissions. All operated on a fast HP computer using an ultralow noise Sound Blaster ZxR soundcard.
